# Manhole Inspection Summary

Manhole # **S13GG\_047MH**

Insp Date: **2/23/09 2:11 PM**

**Location** Address: **2900 BRIGHTON ST** Cross Street: **POPLAR GROVE ST**

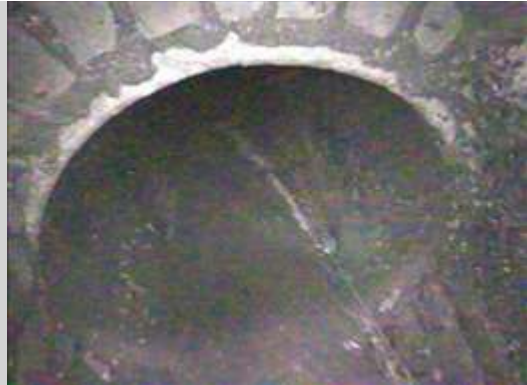
12 O'Clock Outflow

30 in. Circular Gravity Sewer  
Pipe Out @ 12 O'Clock

Pipe Height: **26.4** (in.) Rod and Bar

Pipe Material: **Clay** ☐ Pipe Lined

Infiltration: **None** Pipe Seal Cond: **Sound**
